# Processes for Sustaining Energy in Noncertified Historic Buildings: A Case Study of Smith Plantation

**Abstract:** This paper addresses energy efficiency, indoor air quality, and water consumption in historic buildings. Building sustainability has become a worldwide issue from new construction to existing buildings. Historic buildings make up a large part of existing buildings throughout the world, making it essential that research is done to provide these buildings with sustainable options. The areas of special concerns in renovating historic buildings are improving indoor environmental quality, indoor air quality, water efficiency, and energy efficiency while maintaining the historical value of these buildings. This paper presents a case study of the Smith Plantation in Metro Atlanta, Georgia. The study includes 1) field verification and existing condition assessment of the thermal comfort, energy consumption, and indoor air quality. 2) Building information modeling was used to simulate the energy performance of the buildings as well as determining the CO<sub>2</sub> footprint. These models were calibrated and verified against field readings. 3) the simulation models were used

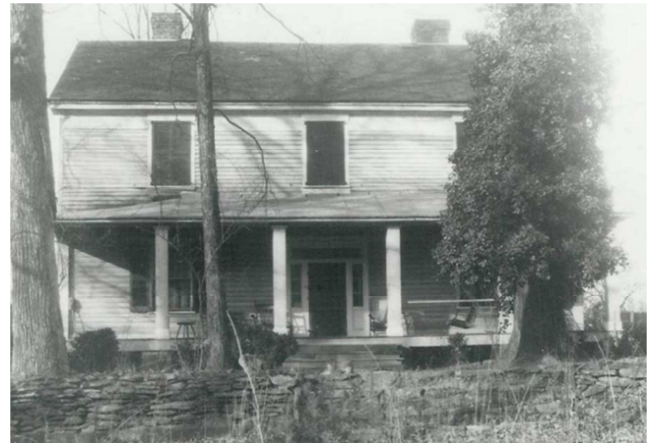
The original house is a two-story structure over a crawl space with a gable roof structure and front porch at the first-floor level. The structure of the main house consists of 2x4 wood studs with no insulation between the studs. They are covered with stucco on the inside and clapboard wood siding on the outside. It has single-pane wood windows and uninsulated wood doors. The roof consists of wood shingles

with attic space and a stucco ceiling. There are hardwood wood floors throughout the house; wallpapered rooms with interior trim that has historical value. The house also maintained its historical furniture and many original pieces of house equipment. Residences personal items are exhibited in the house. Thus, weather control is essential to maintain these items. The original plantation house as it was in 1900, is shown in Figure 1.

**Figure 1.** Smith house in 1900. source: city of roswell. The jaeger company, archibald smith plantation home: master plan report, roswell, 2009.

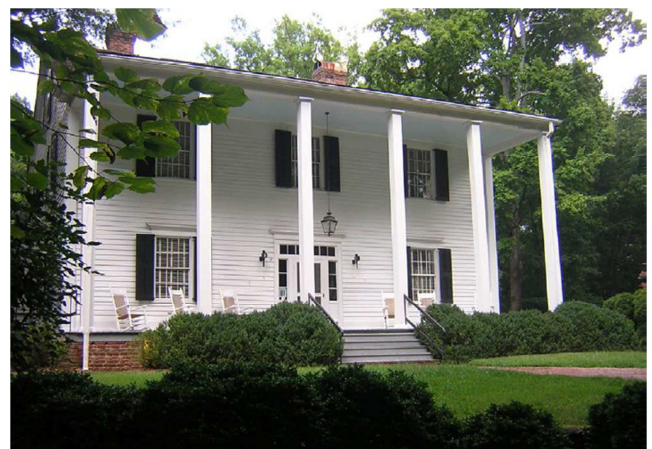
In 1950, the plantation house went through a major renovation, during the renovation larger windows replaced the original ones, which are still single-paned, and the porch was extended and raised to the second-floor level. The windows are, and the exterior doors are also uninsulated wood doors. Currently, it is climate controlled through a central HVAC system for summer and winter. Originally the house had four fireplaces and a wood oven in the kitchen used for heating; these fireplaces are not currently in use. In addition to the HVAC system, there are three dehumidifiers. They are on the first and the second floors and used to control the relative humidity to protect the artifacts in the house. The house currently looks like the picture in Figure 2.

**Figure 2.** Smith house as it is currently. Source: city of roswell. The jaeger company, archibald smith plantation home: master plan report, roswell, 2009.

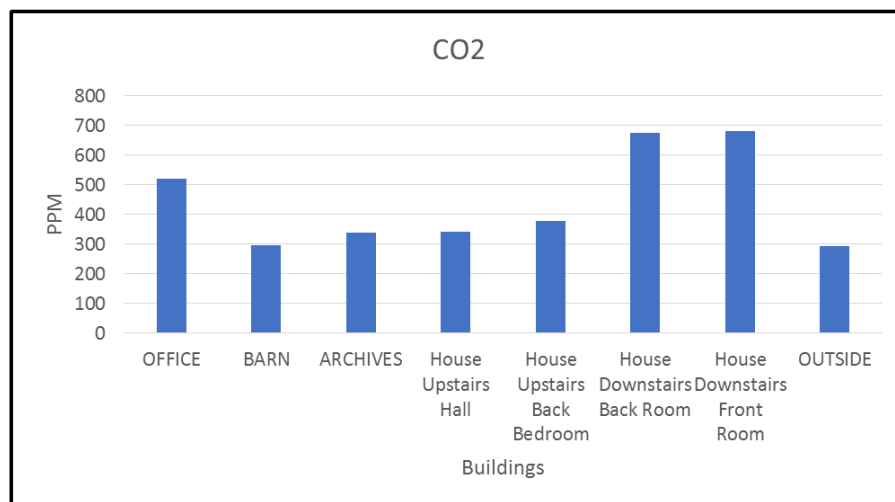
**Figure 3.** CO<sub>2</sub> Levels In The Buildings.

Per Figure 3: CO<sub>2</sub> levels in the buildings and outside show the office and downstairs back, and front rooms of the house have levels much higher than outside. The office is about 250 ppm higher than the 293 ppm outside, and the downstairs of the house is about 380 ppm higher. The outside measurement of 293 ppm is within the normal range for outside. Even though the levels for the office and downstairs of the house are much higher than the outside, they are still within a safe range [13]. An increase in CO<sub>2</sub> levels may be from the number of visitors in the house and the number of employees in the office. All alkane and benzene levels are well under safe ranges. Figure 4 shows the levels of alkane and benzene in the four buildings and the outside.

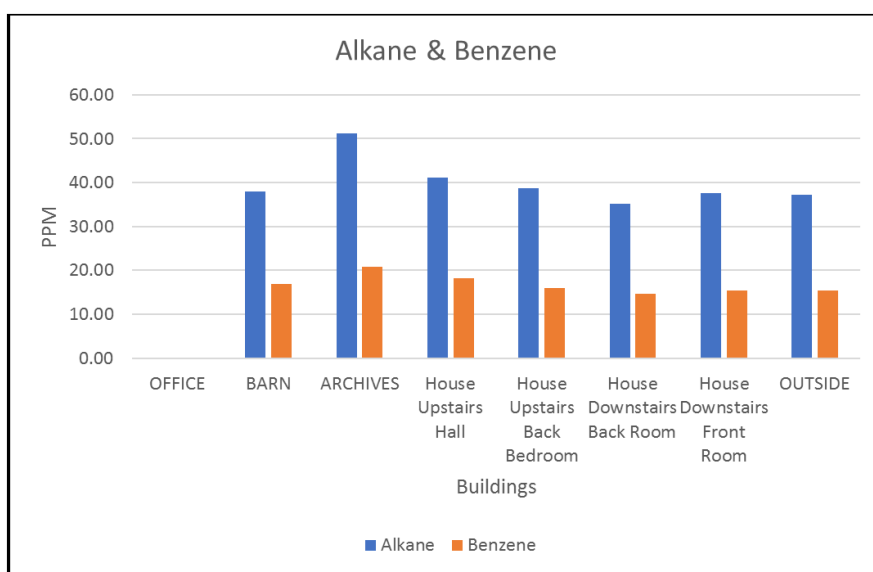
*Figure 4. Alkane & benzene levels in the buildings.*

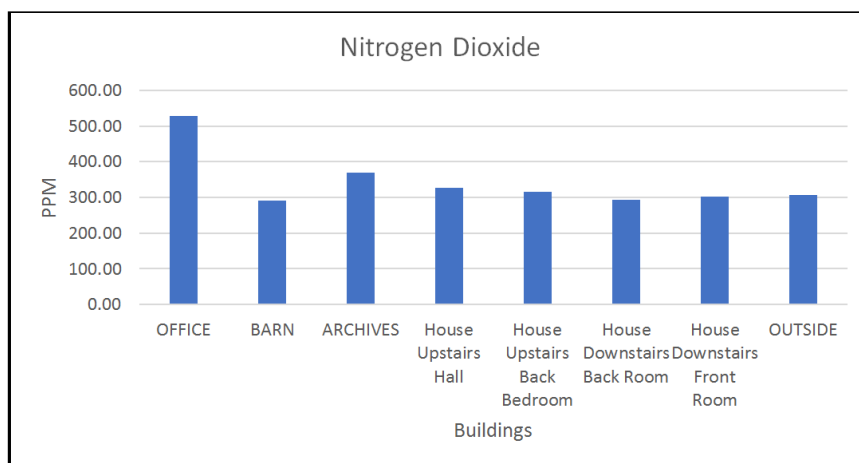
Guide for Nitrogen Dioxide safe levels, the barn and the downstairs back room are in the very unhealthy range. With the levels being in an unhealthy range means that people with lung disease, like asthma, and children and the elderly should avoid being in those buildings. The downstairs front room, outside, and upstairs back bedroom are just slightly over the threshold for being very unhealthy. All other buildings are well above the range [14]. Figure 5 shows the nitrogen dioxide levels.

*Figure 5. Nitrogen dioxide levels in the buildings.*

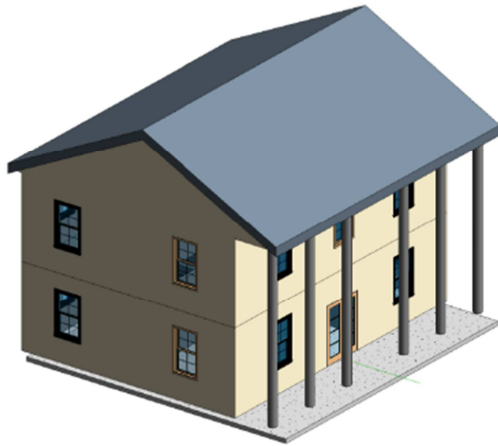
The building model was simulated based on the information and plans gathered from the facility manager. To do an in-depth analysis of the house's building

components, it would require destructive testing, which would defeat the idea of maintaining the authenticity of the building. Calibration was done to match the actual performance of the plantation house. Figure 6 shows the completed Revit model.

Figure 6. Revit model of the plantation house.

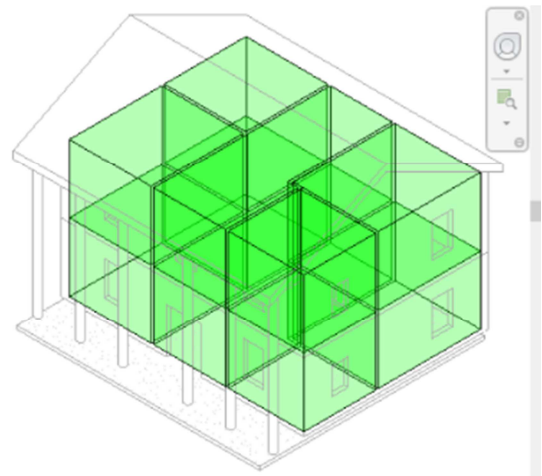
Single-paned glass with 90% SHGC and a U-value of 1.05 were the default for the windows in the simulation model. The house was considered “loose” with an infiltration rate of 1.15 Air Change per Hour (ACH). Field observations were the basis for choosing this infiltration rate. Blower Door testing was not possible because that will interrupt the house function as a historical attraction. The simulation model was calibrated to match the actual performance of the plantation house. The field readings of the indoor and outdoor temperature and RH, as well as the actual energy

consumption, were used to calibrate the simulation model. Figure 7 shows the completed simulation model.

Figure 7. Building simulation model of the house.
